Fracture of a Marine Gear (A)

INVESTIGATION OF FAILURE OF  
LOW SPEED GEAR WHEEL  
DURING FABRICATION

Metallurgical Report No. 728

INVESTIGATION OF FAILURE OF  
LOW SPEED GEAR WHEEL DURING FABRICATION

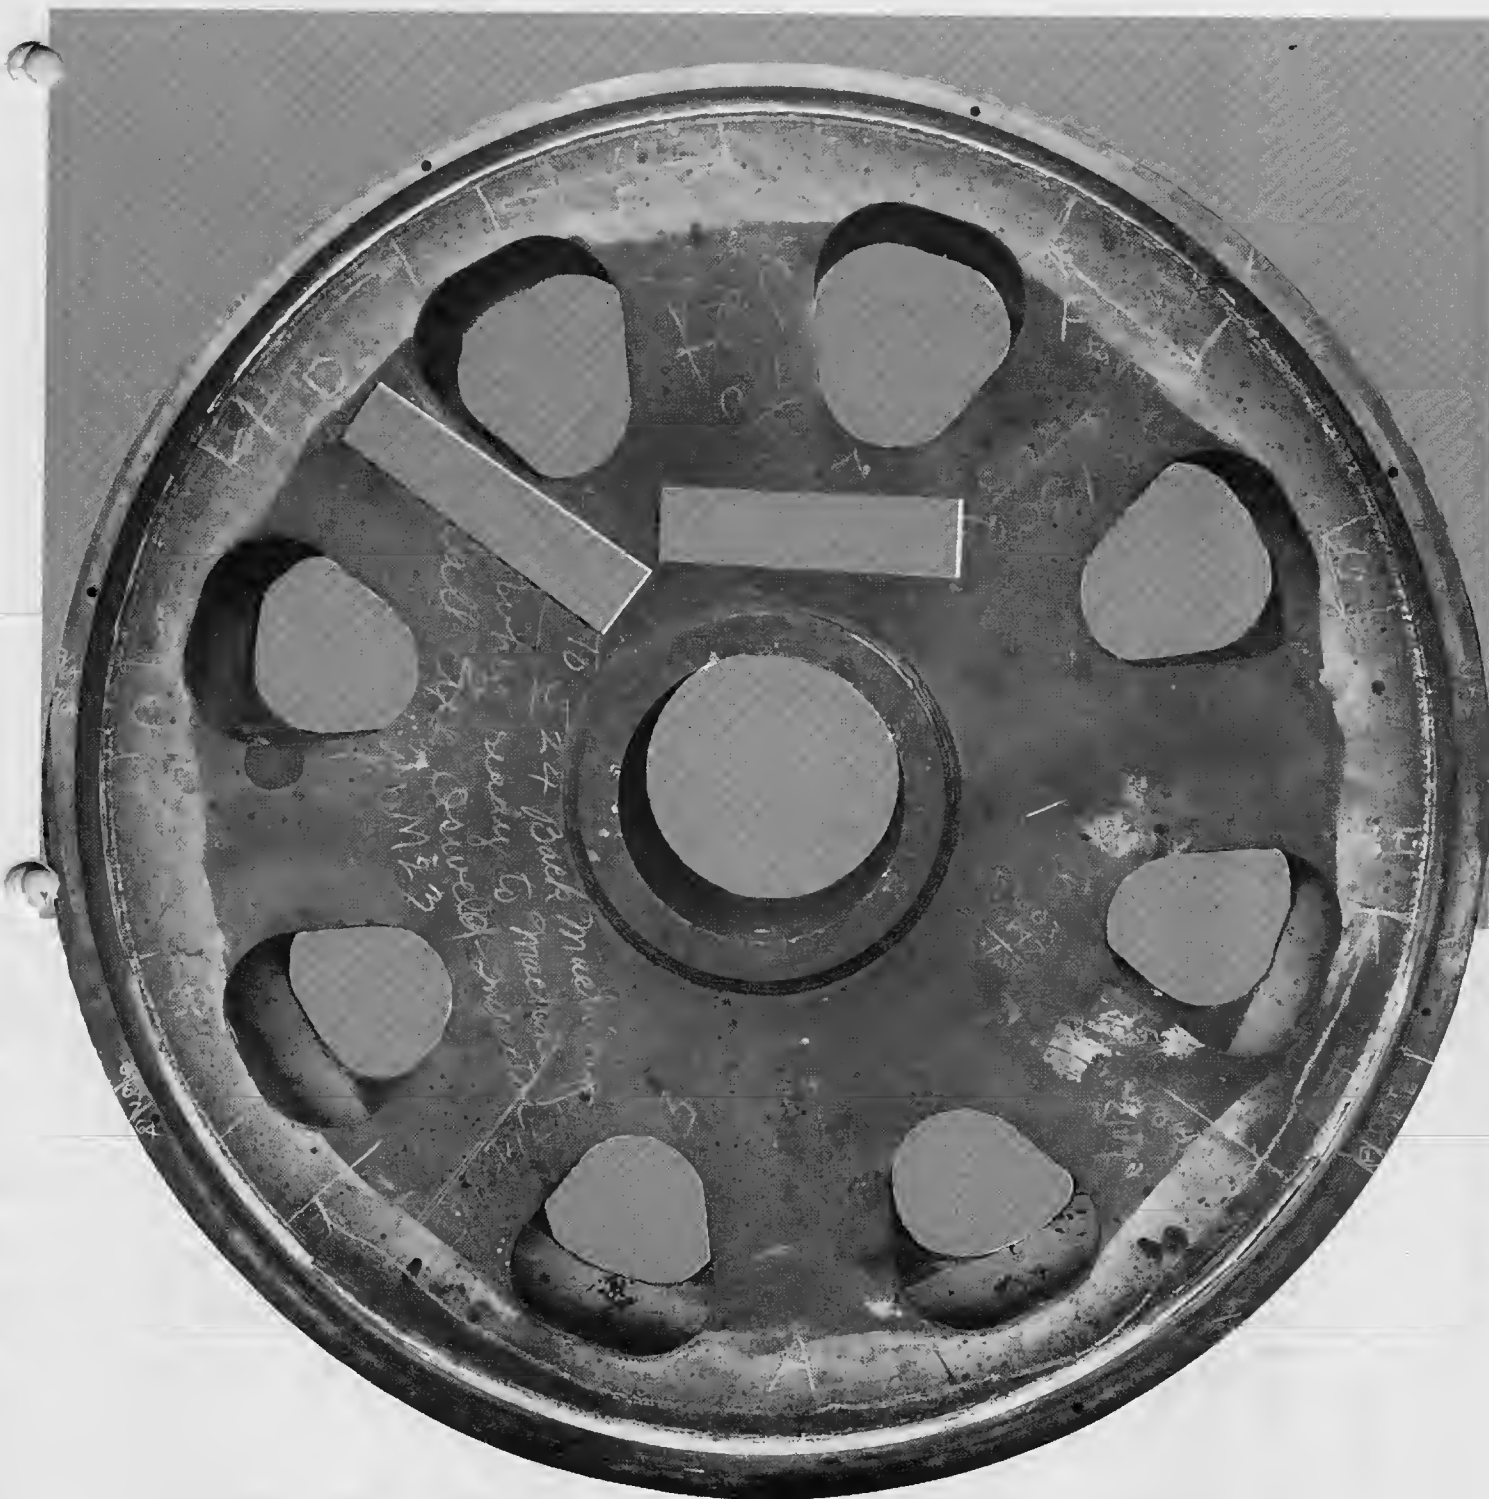
Front view of 93-inch outside diameter low-speed gear that failed during manufacture.

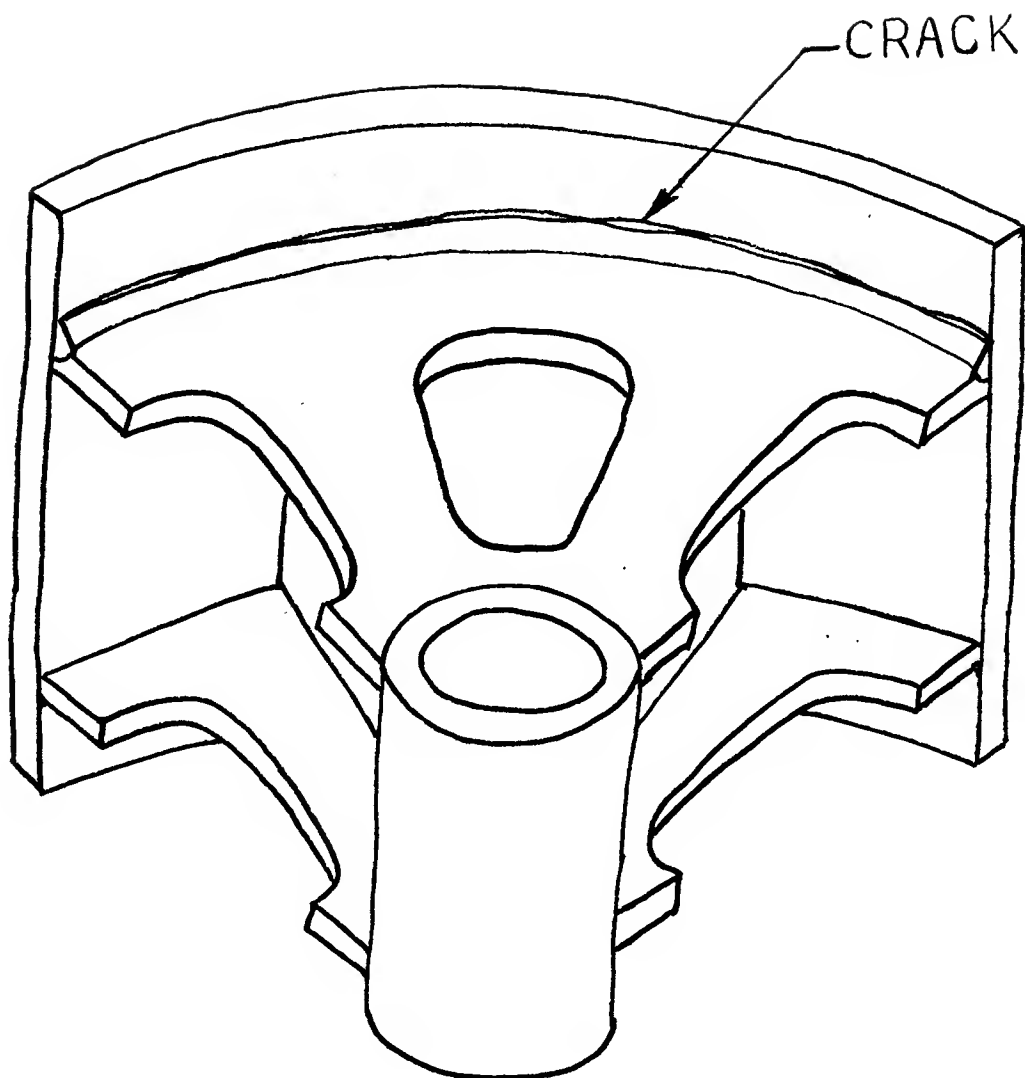
Exhibit 2. Casewriter's sketch of a typical sector of gear showing location and direction of cracks before weld was machined off and gear "exploded". Photographs of cracks after the weld was machined off are shown in Exhibit 4.

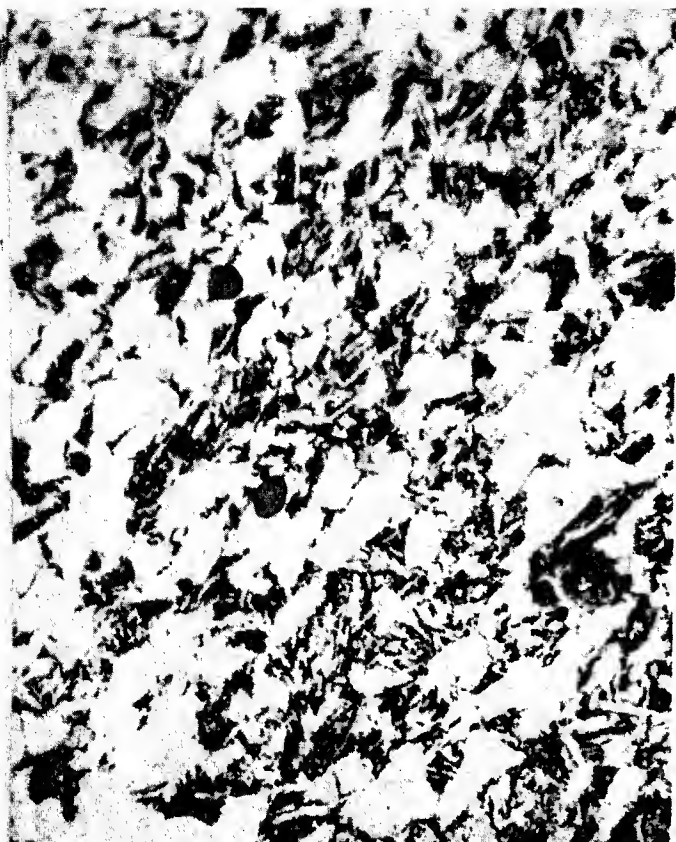
MICROSTRUCTURES OF RIM LB 170 (Heat 64586)

Specimens were removed from rims before and after salvage heat treatment. The effect of water quenching and drawing versus oil quenching and drawing can readily be seen in Figure 1. Note the grain refinement and more uniform carbide distribution in the water quenched and drawn microstructure.

As-Received

(Oil Quenched and Drawn)

- A. Rims made from Heat No. 64586 should be salvaged by reheat treatment of wheel assemblies. This requires water quenching and drawing to improve impact properties of gear rims. The following gear rims are involved:

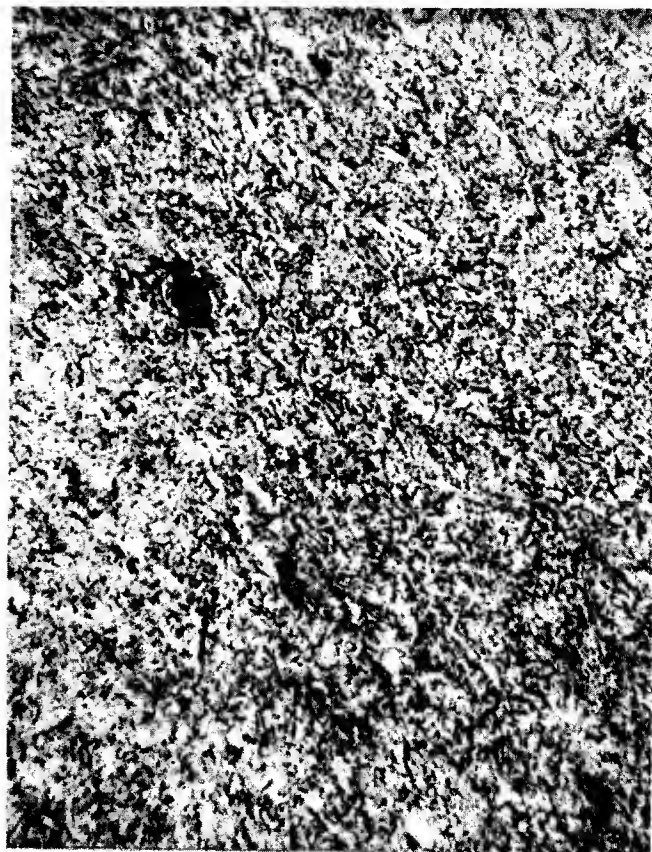
Water Quenched and Drawn

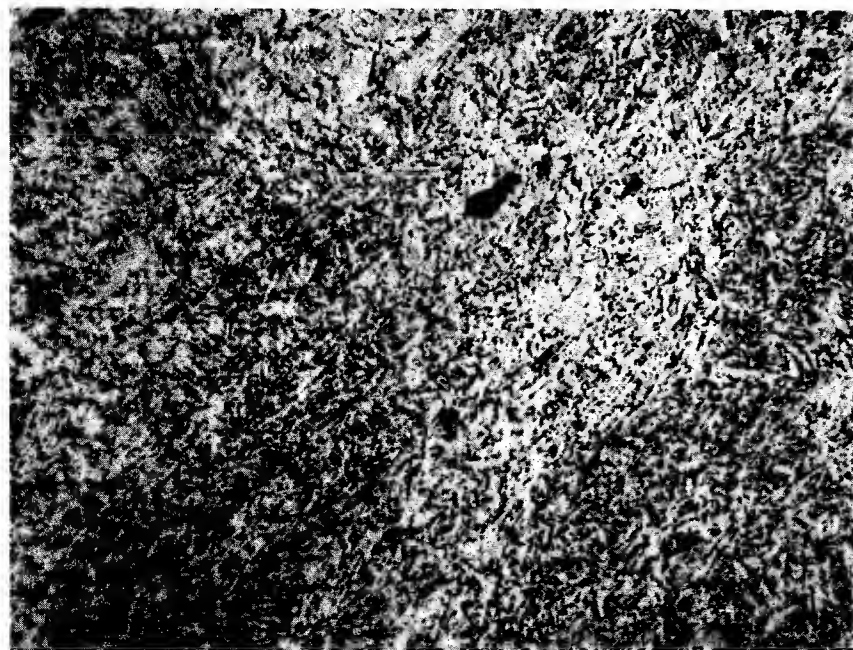
Microstructure of Rim LB 193

In order to confirm that rims LB 191 (Ser. 248140), LB 193 (Ser. 252494), LB 194 (Ser. 252495) and LB 195 (Ser. 253541) had been water quenched and drawn, their microstructures were studied. The microstructure of rim LB 193 shown in Figure 1 confirms that they were water quenched and drawn.
